## HIGH TEMPERATURE STATIC STRAIN GAGE DEVELOPMENT

By  
C.O. Hulse, R.S. Bailey, H.P. Grant,  
W.L. Anderson and J.S. Przybyszewski

United Technologies Research Center

NASA Lewis Research Center  
Contract NAS3-23722  
August 1991

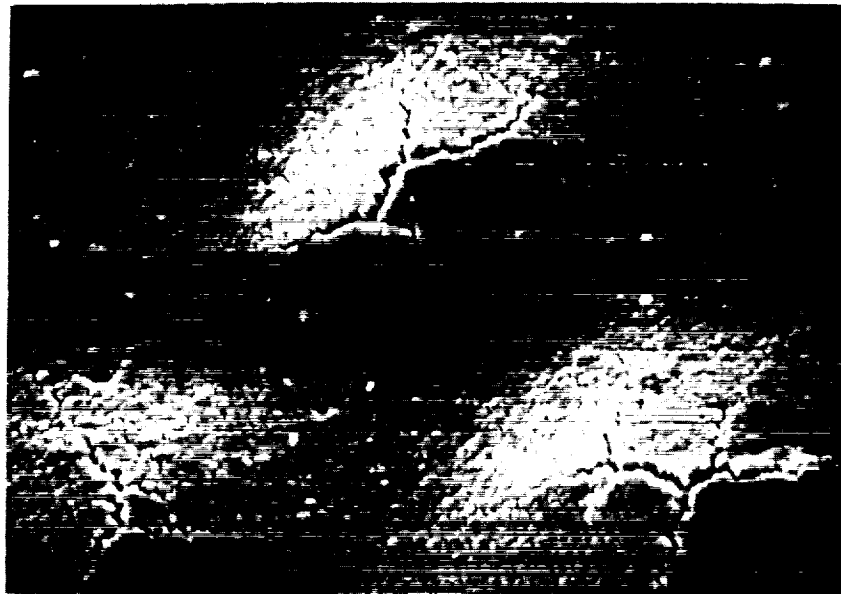
a) FRACTURED BLISTERS

b) TYPICAL AREA

Figure 6.1.2 SEM micrographs of alumina overcoat after 10 hours at 1250 K in air
